Fire Report 15. August 2014

Göppingen - John-A.-Holbrook-Street No. 11

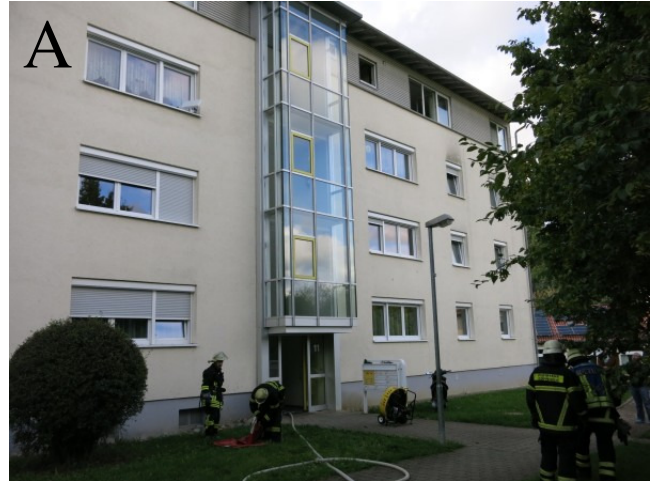
Reported basement Fire in a multi-family apartment building (picture on the right is side A - front view). Smoke can be smelled and light smoke can be seen from the entrance door and down on lower level of the stairwell where several doors (fire resistance of about 30 Minutes). One of these doors was kept open using a wooden chock. The corridor behind this door shows quite a bit of smoke. Several people have been reported to be still in the building, some of them would have difficulties in leaving the building. So to clear the building would have taken several minutes. A decision was made to keep the people in the building and use a defensive ventilation to keep smoke from the basement fire out of the stairwell during further operation.

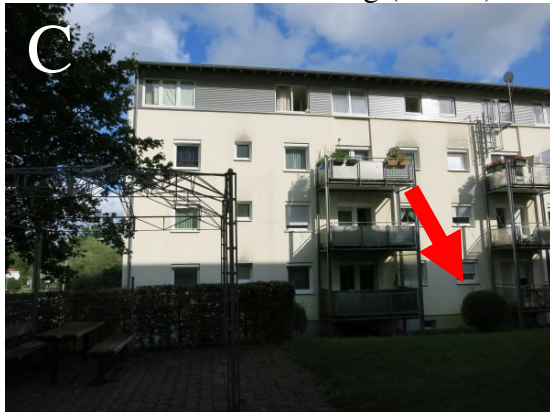
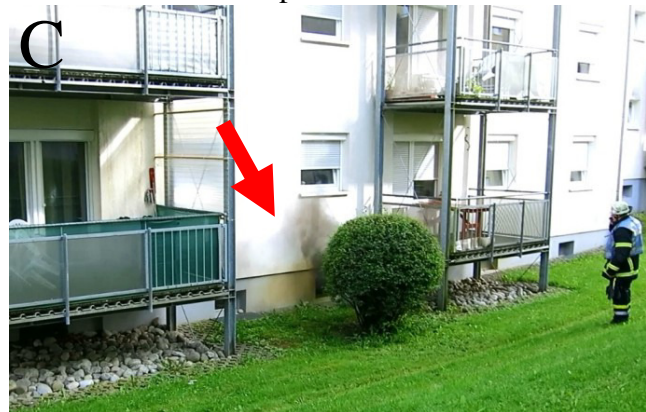
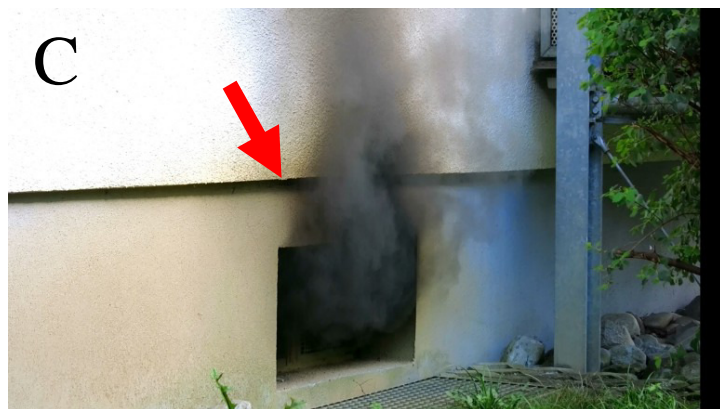
The back side of the building (Side C) is shown in the next three pictures:

One window in the basement showed smoke coming out in a pulsing way, indicating that there is a moderate fire in the basement which is underventilated and probably some "plastic material" is involved. Several windows have been open in the apartments on Side C.

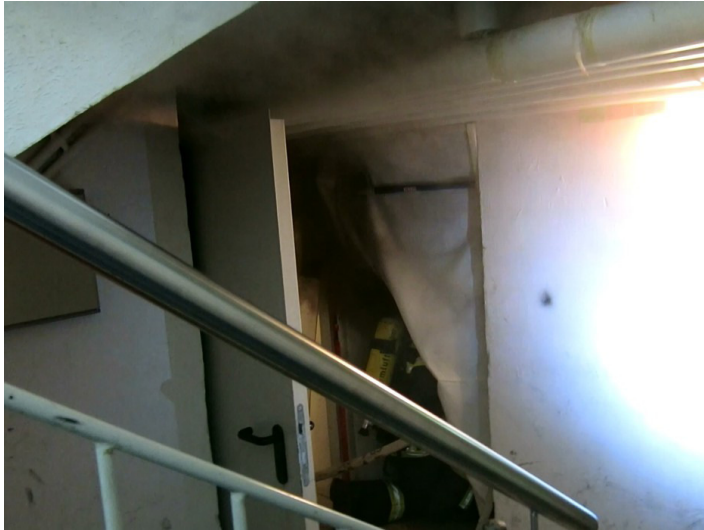
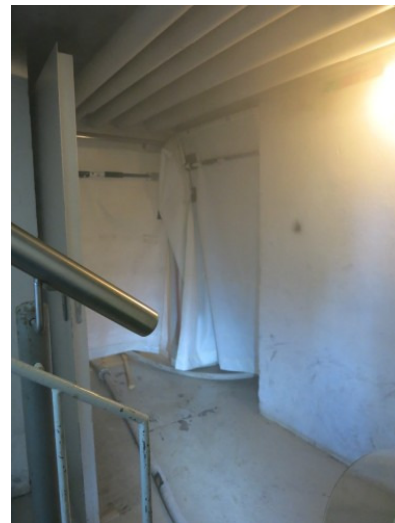
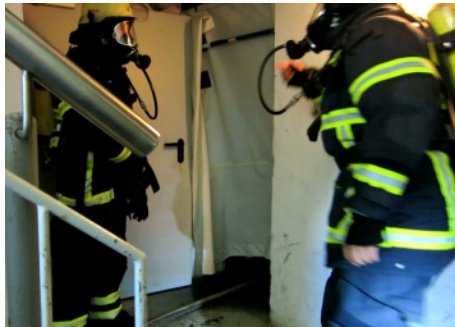
Installing a Smoke Blocking Device into this door frame the first attack team entered the fire compartment with a charged hose to reach the seat of the fire. In this picture the amount of smoke flowing into the stairwell without a blocking device is obvious. Two smoke blocking

devices were used in total to control the air flow in the desired direction. With their aid it was possible to divide the one big problem (a room fire next to the stairwell in a building with multiple occupants) into two smaller problems which are quite easy to handle with the available resources (staffing and material).

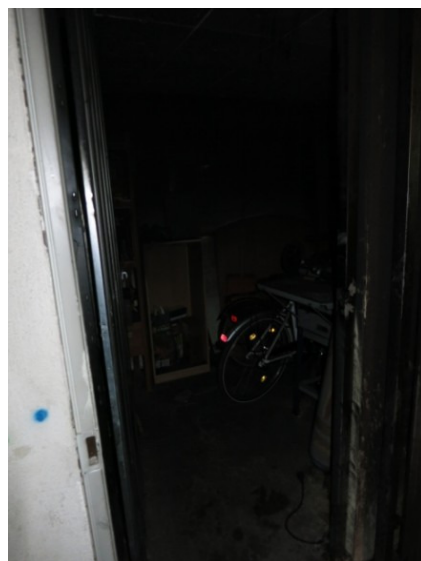
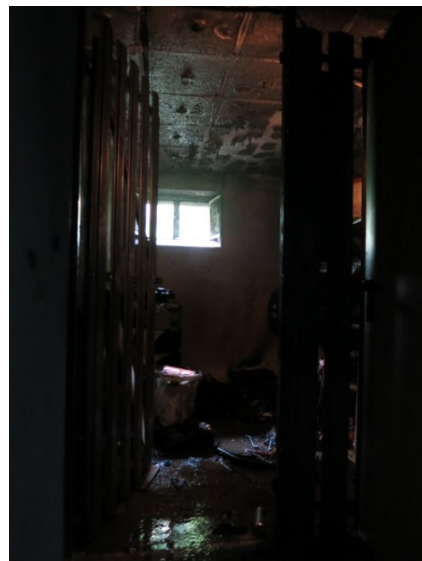
To get in and out of the fire compartment fire fighters just lifted the smoke blocking device. The damage in the fire compartment can be seen on the last two pictures below. The storage areas of two apartments were severely damaged, quite a lot of plastic and also flammable liquids have been on fire. About 10 m² of combustibile insulation material at the basement ceiling also contributed to the fire.
