Fire Report 15. August 2014

Göppingen - John-A.-Holbrook-Street No. 11

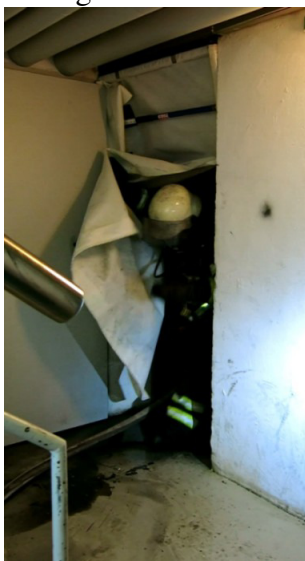
To get in and out of the fire compartment fire fighters just lifted the smoke blocking device. The damage in the fire compartment can be seen on the last two pictures below. The storage areas of two apartments were severely damaged, quite a lot of plastic and also flammable liquids have been on fire. About 10 m² of combustibile insulation material at the basement ceiling also contributed to the fire.
